# SERVICE BULLETIN

**TITLE: FUEL - INTRODUCTION OF IMPROVED FUEL CELL GASKET**

This Service Bulletin is being issued to install a more moisture-resistant gasket for use on the fuel cell covers.

This Service Bulletin announces a fluorosilicone rubber gasket, P/N 50-921587-9, which replaces gasket P/N 50-921587-7.

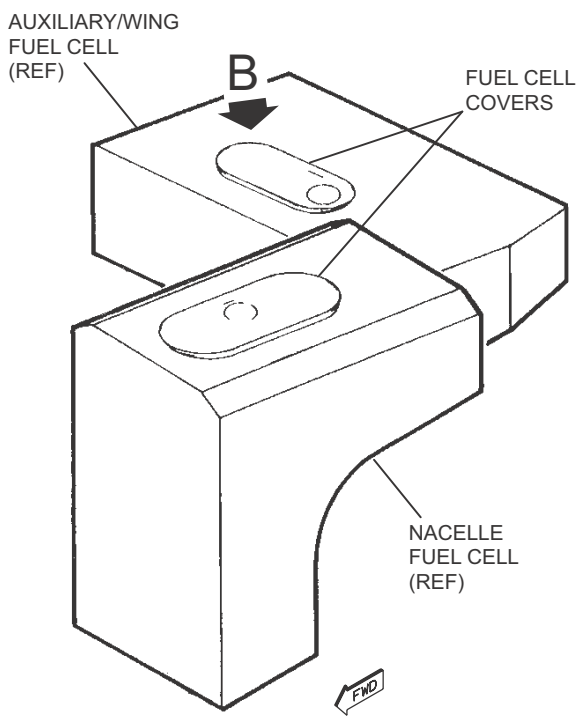
**DETAIL B**  
AUXILIARY/WING COVER SHOWN  
(NACELLE COVER SIMILAR)

It is important to tighten access panels in a definite pattern to ensure uniform compression of seals and prevent possible fuel seepage. When securing the panel, initially snug the screws in the defined sequence, then tighten the screws in the same sequence. Refer to Figure 1, Detail B.

- (b) Install bolts, new P/N MS35333-40 locktooth washers, and retained P/N AN960-416L flat washers (flat washer against cover).
- (c) Torque bolts to 35 to 40 inch-pounds in the sequence shown.
- (d) Check torque in sequence shown and re-torque bolt **only** if torque is lower than 30 inch-pounds.
- (12) Install plumbing and electrical wiring removed in Step (6) to access fuel cell. Refer to applicable MM, Chapter 28-40-00.
- (13) Repeat fuel cell gasket replacement procedure on opposite nacelle fuel cell.
- (14) If airplane is equipped with auxiliary or center wing fuel cells, proceed to Step (15). If not, proceed to Step (25).

- (b) Install bolts, new P/N MS35333-40 locktooth washers, and retained P/N AN960-416L flat washers (flat washer against cover).
- (c) Torque bolts to 35 to 40 inch-pounds in the sequence shown.
