# SERVICE BULLETIN

**TITLE: STABILIZERS - INSPECTION/REPLACEMENT OF ELEVATOR BALANCE WEIGHT ASSEMBLIES**

Model 58, Baron, Serials TH-1768 through TH-2110.

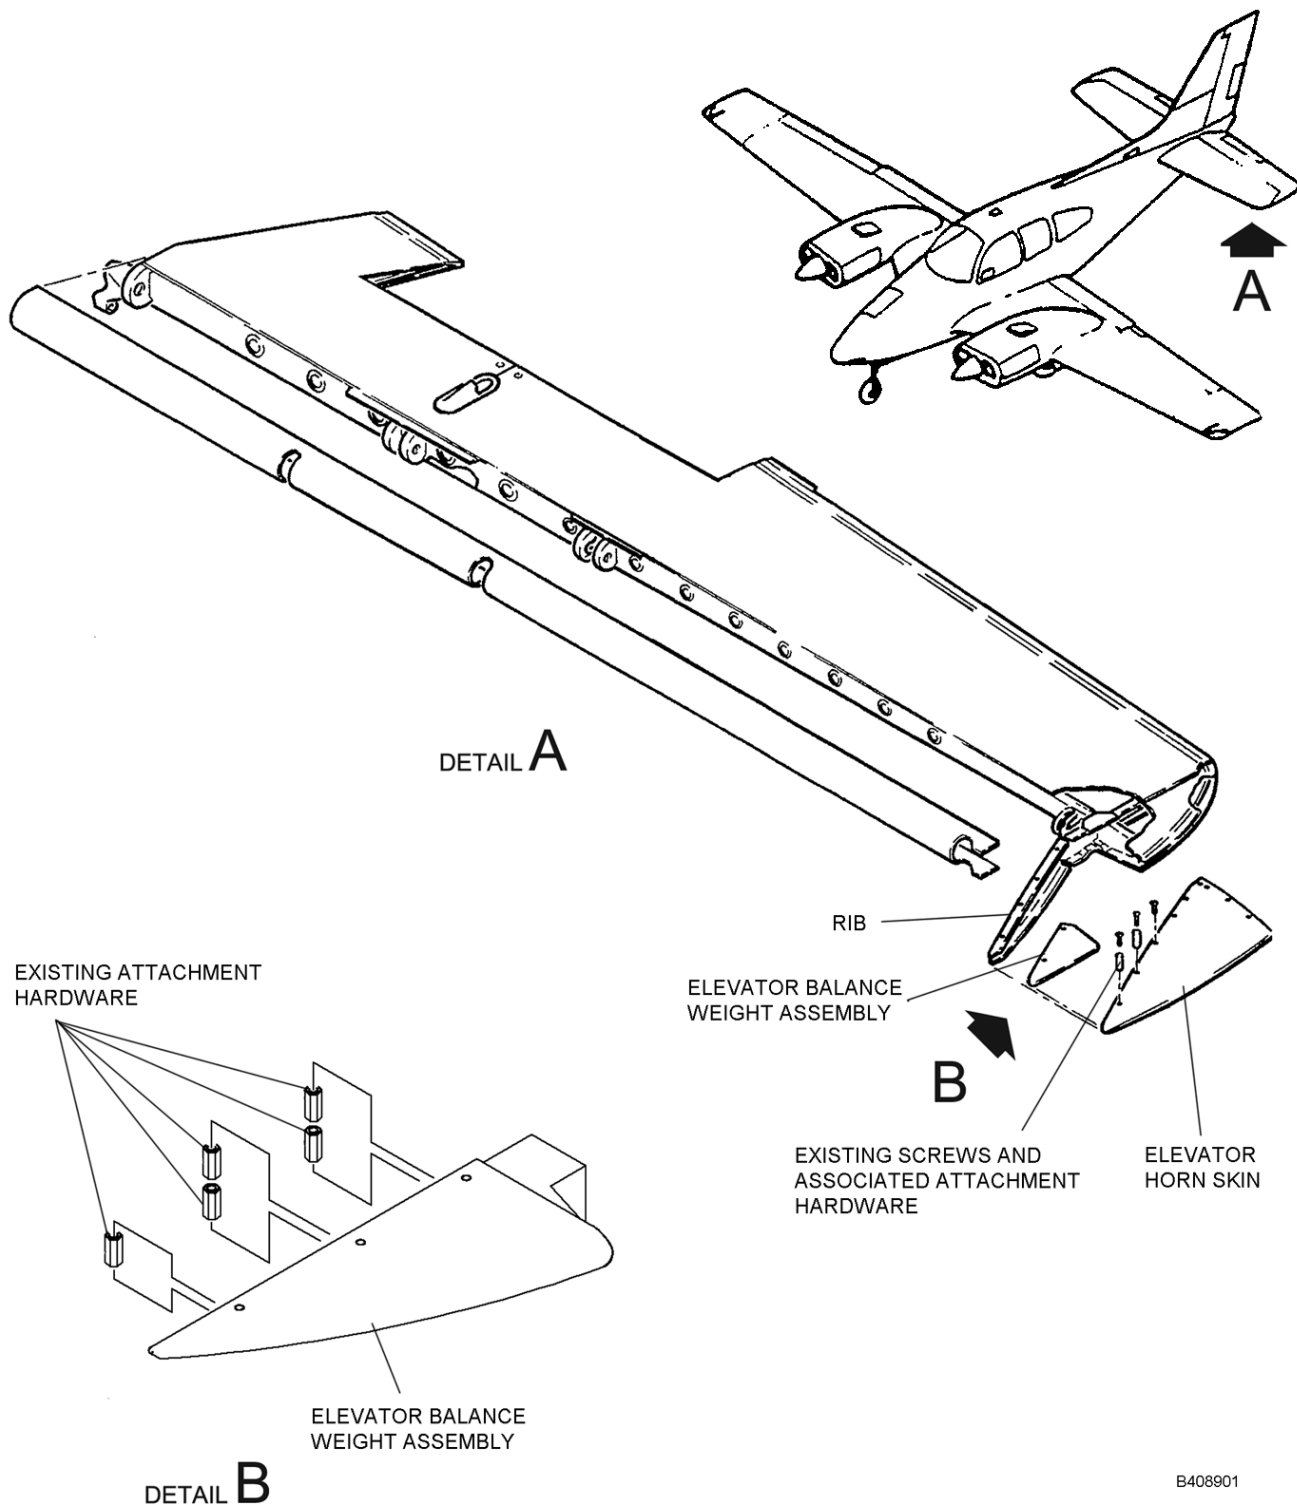
**Inspection of Elevator Balance Weight Assembly  
Figure 1**

This Service Bulletin is being issued to inspect for proper installation of the existing elevator balance weight assemblies. The potential exists that the existing elevator balance weight assemblies are not sufficiently hardened in accordance with Hawker Beechcraft Corporation (HBC) standards. A balance weight assembly that is not sufficiently hardened may become misshapen and has the potential to become dislodged. This condition could result in an unbalanced elevator.

- (2) Gain access to the elevator and locate the existing elevator balance weight assembly that is installed under the elevator horn skin. Refer to Figure 1 and Figure 2.

- (3) Visually inspect to determine if the existing elevator balance weight assembly is in position and protruding from the edge of the rib. In addition, verify that the elevator balance weight assembly attachment screws on upper and lower surfaces are secure and the installation holes show no sign of discoloration. Refer to Figure 1 and Figure 2.

- (b) If the existing elevator balance weight assembly has become dislodged, the attachment screws are not secure, or the installation holes show signs of discoloration, proceed to Step (4).

- (4) Remove the existing screws and associated attachment hardware from the elevator horn skin. Retain the removed screws and associated attachment hardware.

- (5) Remove the existing elevator balance weight assembly from its position under the elevator horn skin.

- (6) Weigh the removed elevator balance weight assembly to determine which replacement elevator balance weight assembly shall be installed. Part numbers apply to the weight of the removed elevator balance weight assembly as follows:

- (7) Use the screws and associated attachment hardware that were retained in Step (4) to install the applicable new elevator balance weight assembly. **Note:** New hardware may be used as necessary, as defined in Paragraph 2.C.2. The installed elevator balance weight assembly shall protrude from the rib as shown in Figure 2.
